LANE COVE TUNNEL COLLAPSE AND SINKHOLE A FORENSIC REVIEW - 1: THE COLLAPSE

Brian C Burman¹, Gregory P Kotze² and Laina Chan³

LANE COVE TUNNEL COLLAPSE AND SINKHOLE A FORENSIC REVIEW - 2: POST FAILURE INVESTIGATIONS

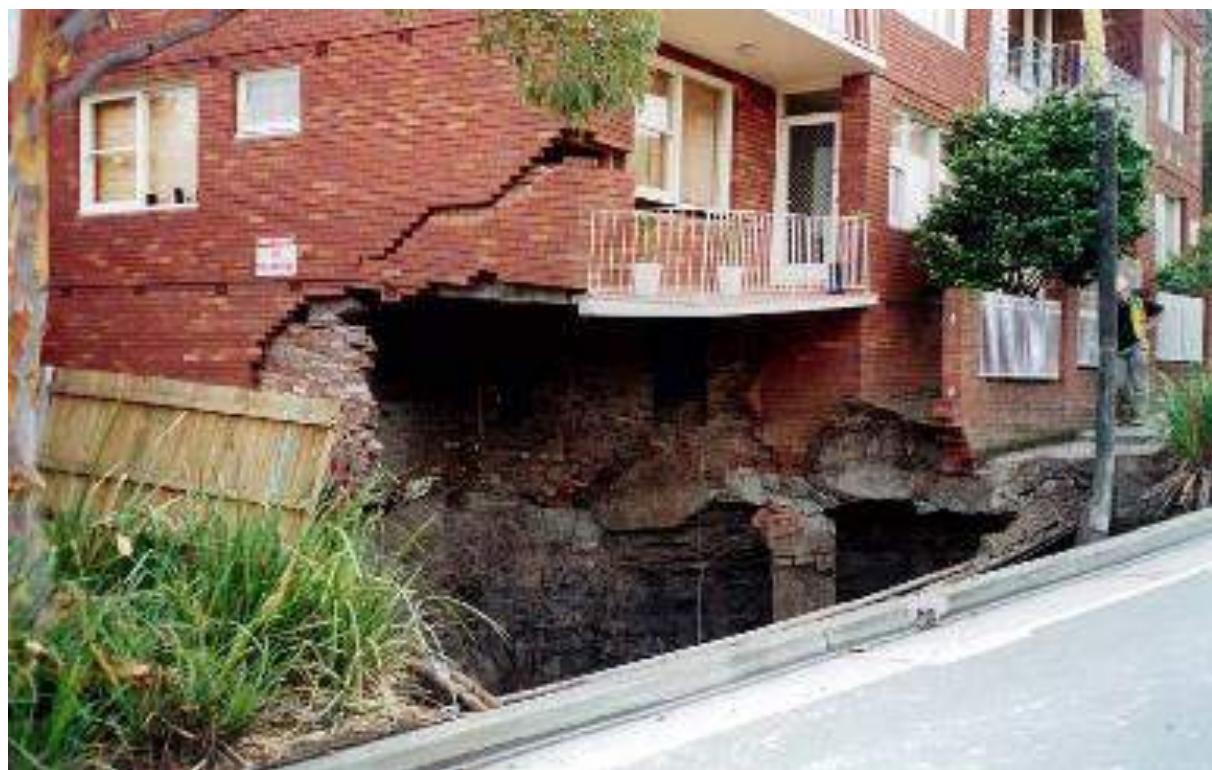
Figure 1: Damage to Kerslake Apartments and the surface expression of the sinkhole

By about 2:00am the sinkhole was observed in front of Kerslake Apartments and by 5:30am it had expanded in size to be around 8 to 9 m in diameter. At about 6:00am a secondary collapse occurred involving a number of retaining wall piles and the decision was made to fill the hole with mass concrete to mitigate any further collapse. The spoil from the collapse buried the road header and a Caterpillar loader (Figure 2) but fortunately the 4 members of the tunneling crew retreated from the area without suffering physical injury.

There was structural damage to Kerslake Apartments; to the Longueville Road retaining wall; to Telstra's fibre optic cables copper cables and a co-axial cable; to water mains and pipework; to underground electrical cables; and nearby service businesses. The agreed amount of consequential damage to tenants and owners of Kerslake Apartments; plus economic loss to the affected commercial interests was \$21m plus interest, which the Court awarded two-thirds to PB and one-third to PSM.

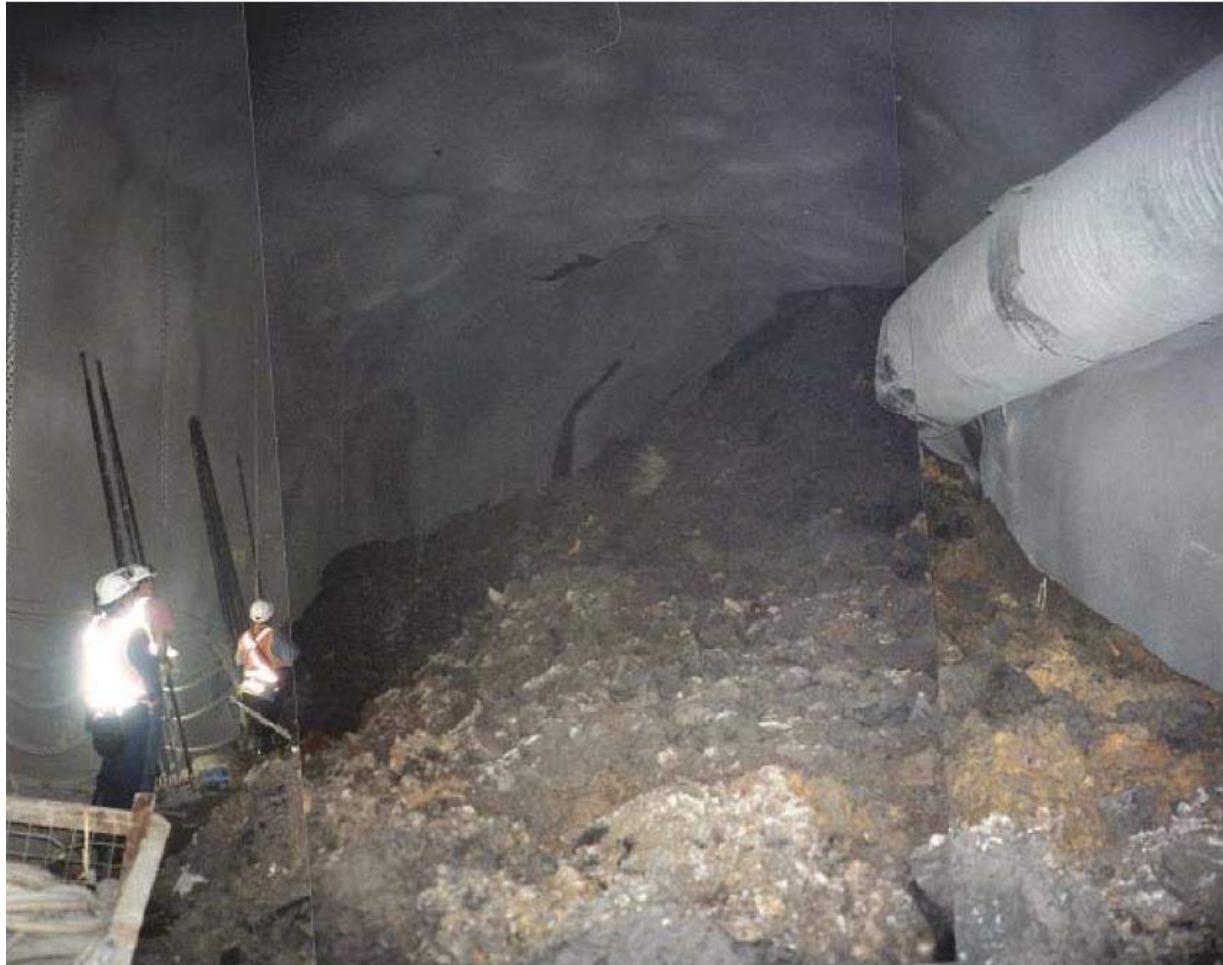
Figure 2: Collapse debris in MC5B ventilation tunnel looking north towards the blocked intersection, 3 /11/2005

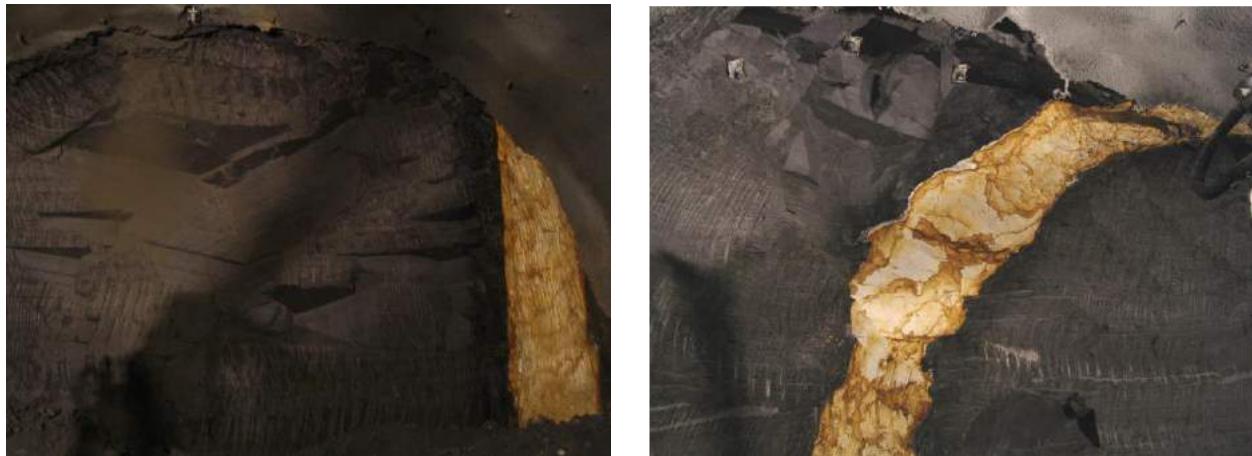
The southern splay of the bifurcated dyke and its extension through the MC5B/MCAA intersection was encountered, documented and photographed, between MC5B Ch 126m to 152m, 178m to 191m and for approximately 8m into the MCAA downdrive (Figure 4). Photos of the MC5B dyke are included as Figure 5 at Ch 152 and 186, left and right respectively. Typically the dyke margins were planar to irregular, intact sub-vertical boundaries with the host rock being Class III/IV shale showing no sign of significant alteration or weakening.

Figure 5: Dyke exposures in the MC5B tunnel at Ch152 (left) and Ch186 (right)

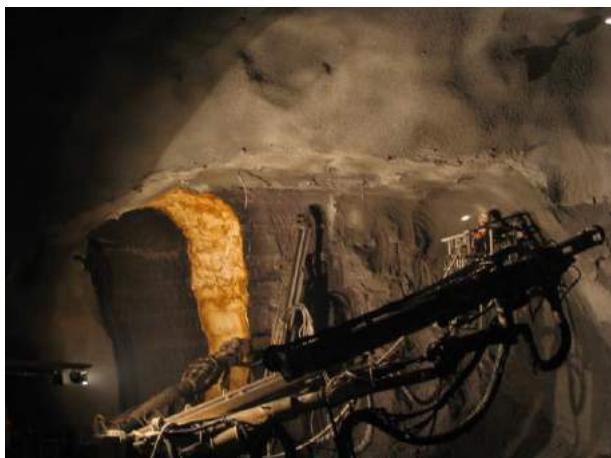
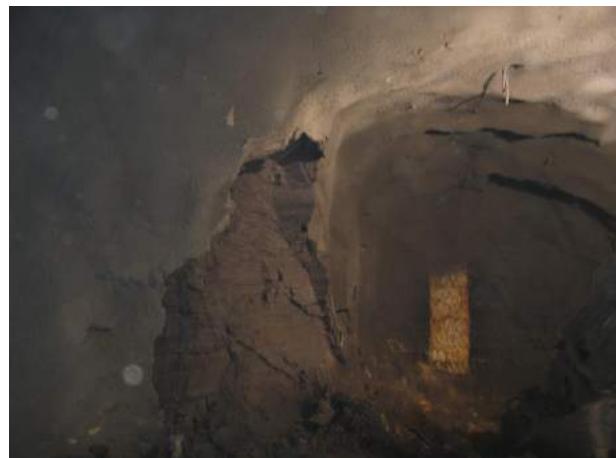
Figure 8 shows the downdrive breakout on 28 October (left photo) and the partial face advance on 1 November 2005 (right photo) with instability on the left chamfer. The collapse occurred at about 2am on Wednesday, 2nd November 2005.

Figure 8: Downdrive breakout on 28 October (left) and the partial face advance on 1/11/ 2005 (right)
